REPORT NO. FHWA - CA - TL - 78-13

Vehicular Impact Tests Of Precast Concrete Median Barriers With Corrugated Ends And Tensioned Cables

**FINAL REPORT
JUNE 1978**

Caltrans
CALIFORNIA DEPARTMENT OF TRANSPORTATION

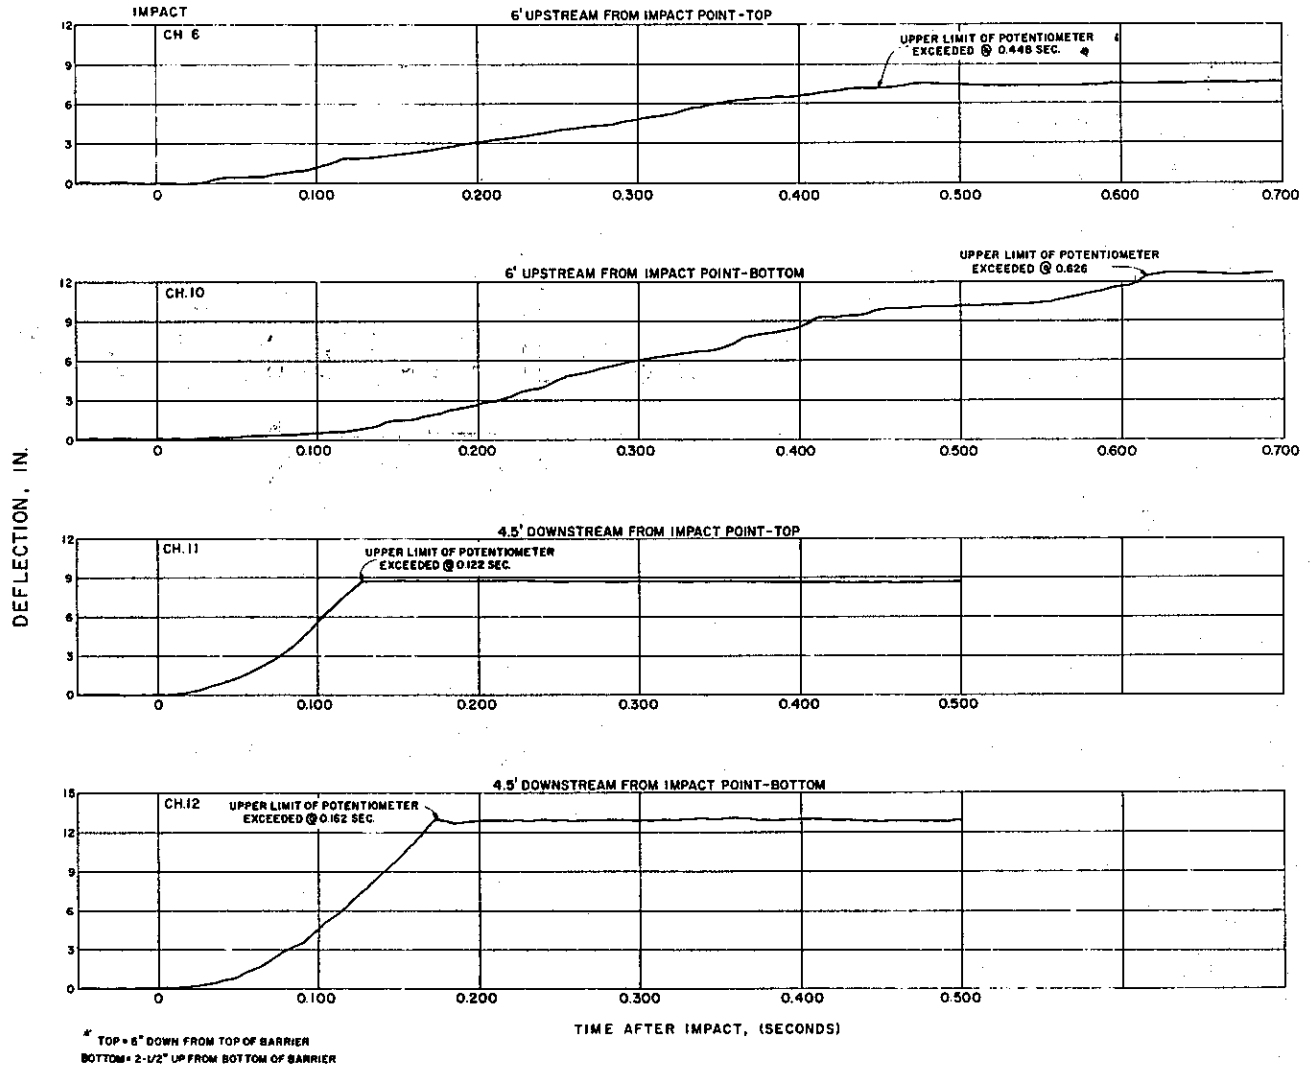
Figure 13A, BARRIER DEFLECTION VS TIME

TEST 332, 4600 lb. VEHICLE, 60 mph., 25°
 PRECAST TYPE 50V CONCRETE MEDIAN BARRIER
 WITH TENSIONED CABLE
